LIMITED SOIL INVESTIGATION  
for  
THE CASTRO ADOBE  
SANTA CRUZ COUNTY, CALIFORNIA

BY  
JAMES C. REYNOLDS & ASSOCIATES, INC.  
GEOTECHNICAL ENGINEERS  
85123-S76-H2  
December 1985

STRUCTURAL COMPUTATIONS  
for —  
THE CASTRO ADOBE  
SANTA CRUZ COUNTY, CALIF.

END WALL  
FOUNDATION  
REPAIR WORKS

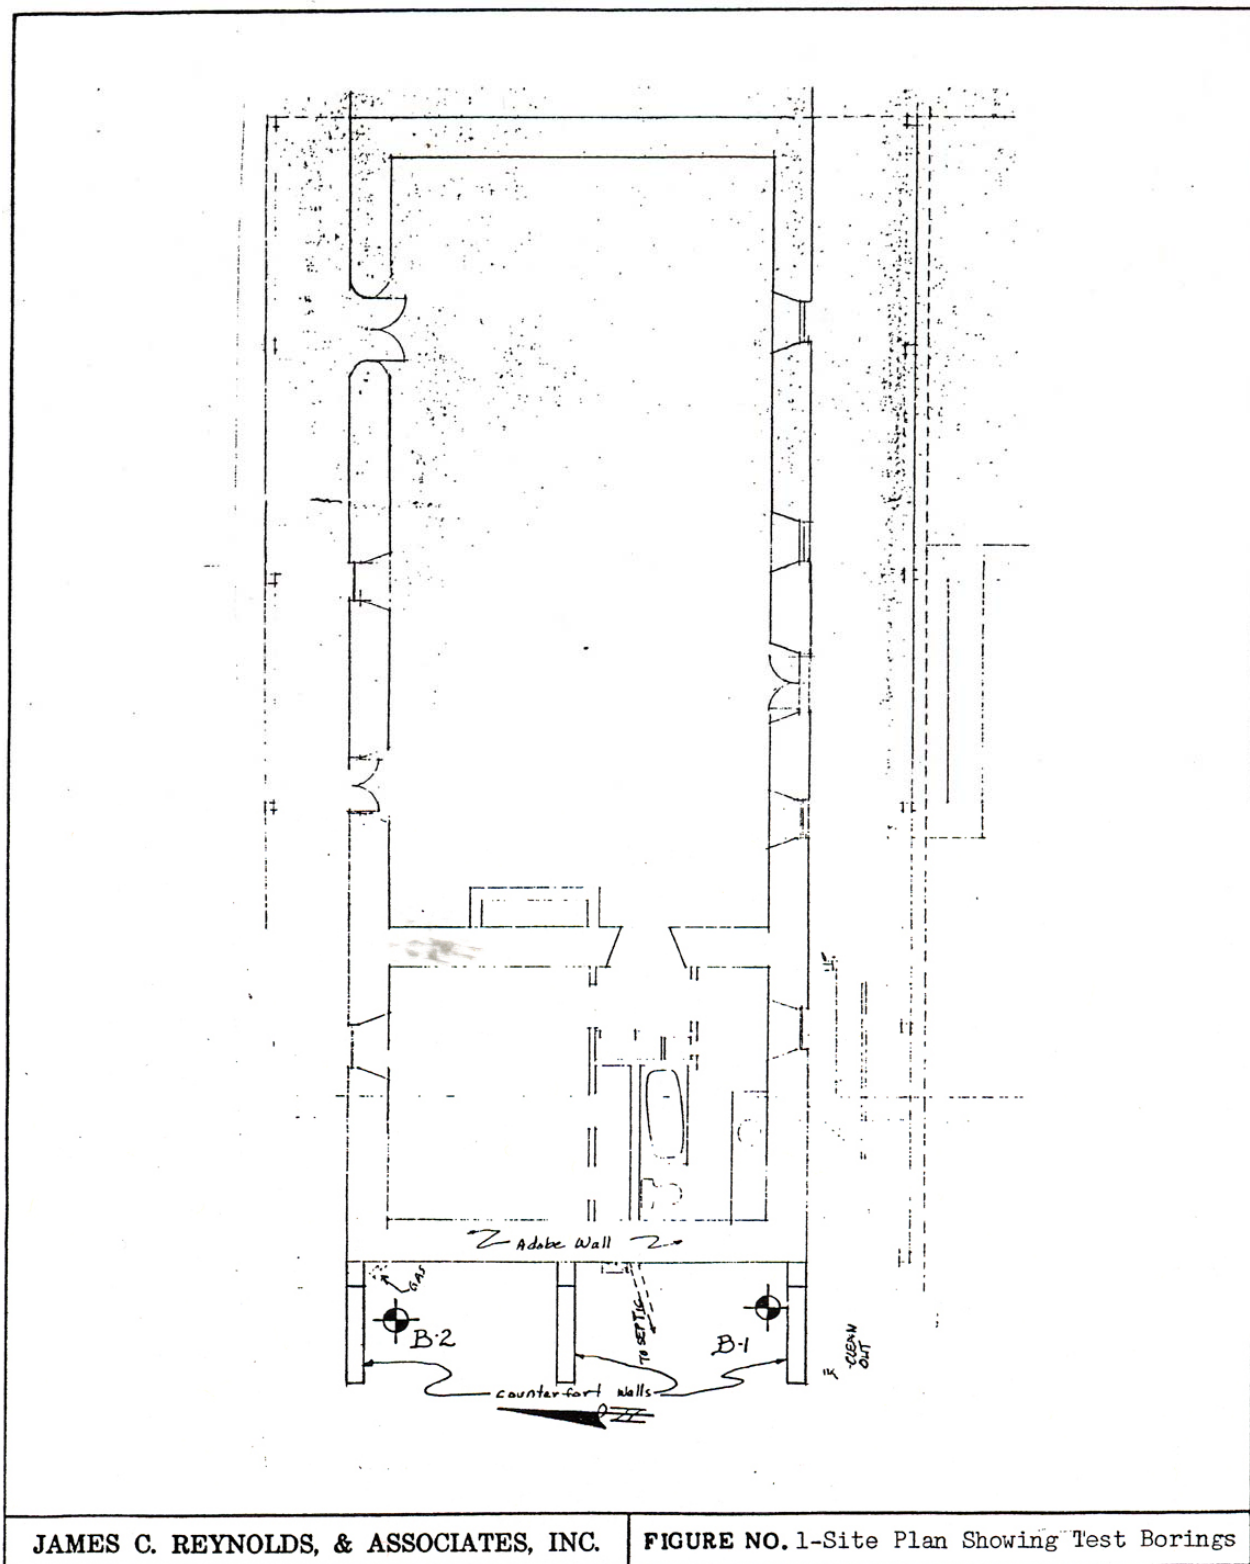
FIGURE NO.1-Site Plan Showing Test Borings

Santa Cruz County. The site is at the crest of a north-south trending ridge. At the time of our field investigation the west end of the two-story adobe building had evidenced measurable subsidence. This subsidence has also extended down the north and south exterior walls some ten to twelve feet. A recent excavation along the west wall indicates that the west wall foundation consists of a place stone footing, which extends about eight inches below the ground surface. Three counterfort type walls have been placed perpendicular to the west wall, see Figure No. 1, "Site Plan Showing Test Borings."

The field investigation was conducted on 6 December 1985, with the drilling of two test borings at the approximate locations shown on Figure No. 1, "Site Plan Showing Test Borings."

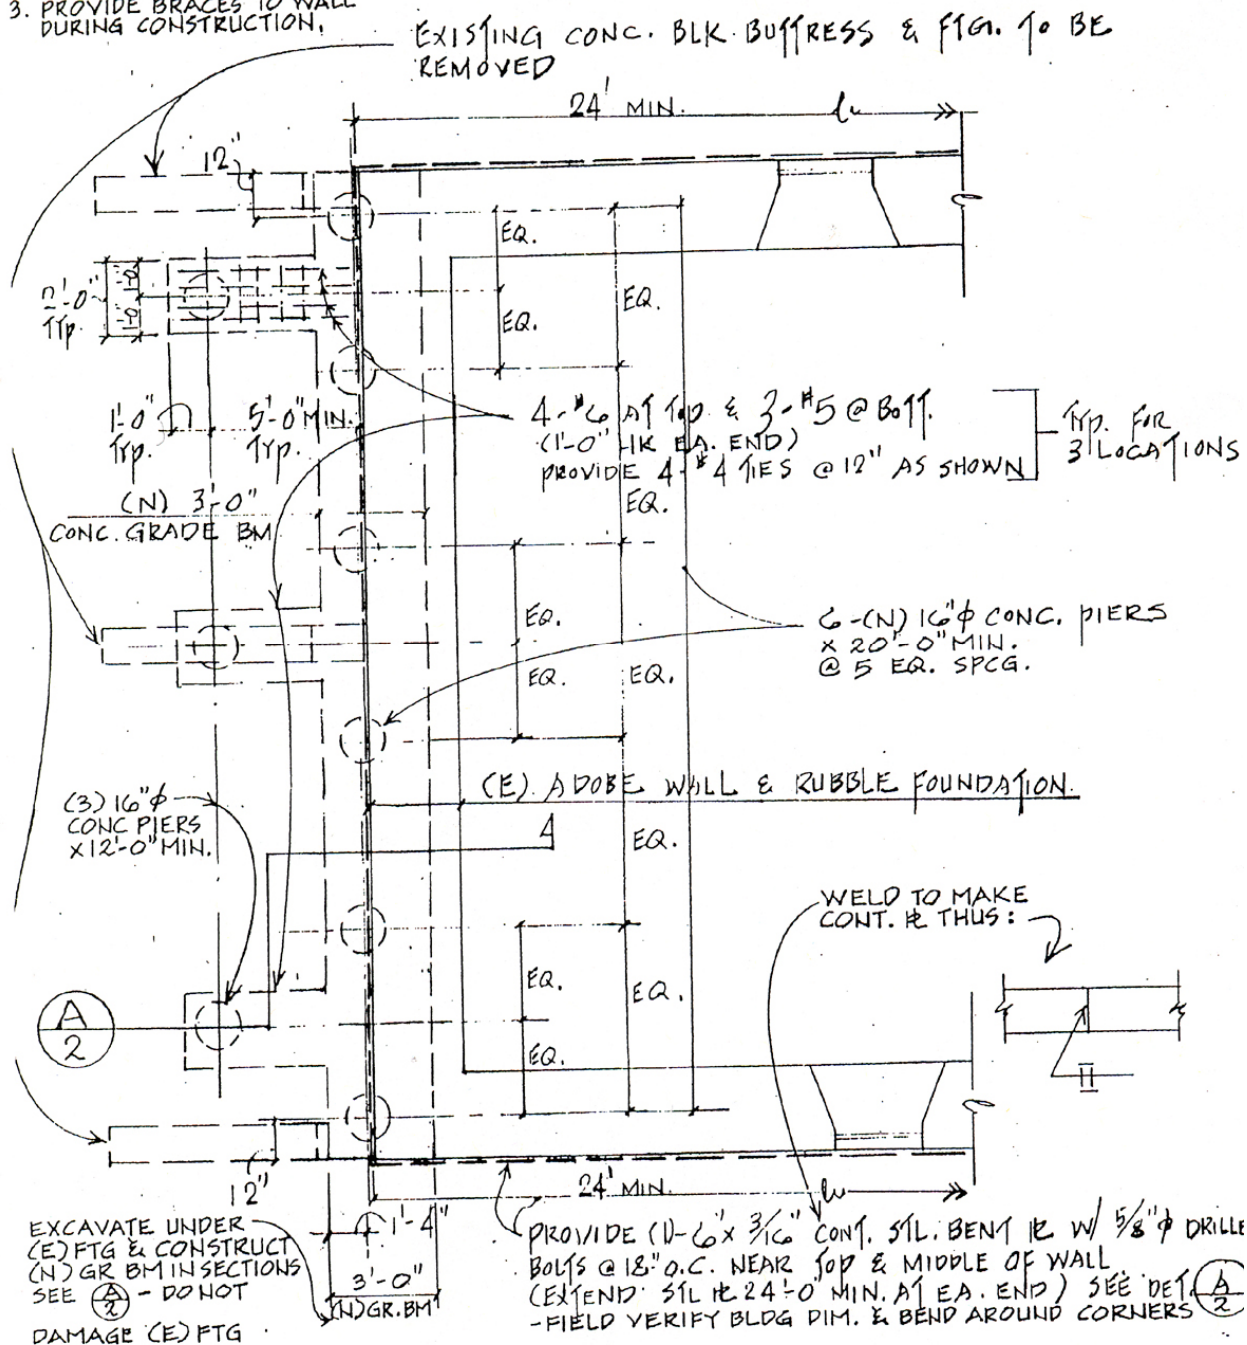
PARTIAL EXISTING FOUNDATION PLAN (NO SCALE)

3. The original stone formation and the subsequent three counterfort footings are all founded within the upper stratum of loose clayey sand material; the original footings have about three feet of loose soil beneath them while the counterfort wall footings are resting on at least eighteen inches of loose material. These footings were destined to undergo eventual subsidence, particularly following the two very wet winters of 1982 and 1983.
4. Because of the loose surface soil stratum, we recommend that the western wall of the adobe residence be underpinned, and supported by reinforced drilled cast-in-place concrete piers and grade beam.

END YML  
FOUNDATIO  
REPAIR WORKS
